Model	Applicable To	File Under	Bulletin No.
1994 - 96 ACCORD 1995 - 96 ODYSSEY	See VEHICLES AFFECTED	BRAKES	93-038
			Issue Date APRIL 8, 1996

ABS Light Comes On (Supersedes 93-038, dated January 16, 1995)

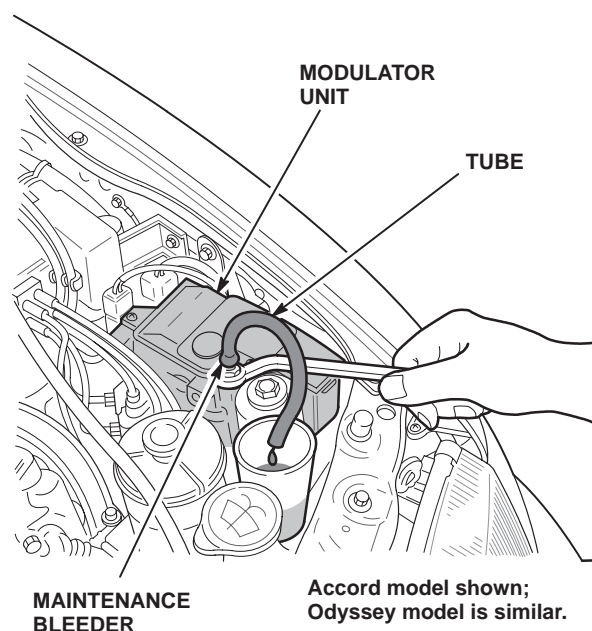
The ABS light comes on, and the ABS control unit stores a code 1.

Air trapped in the pump inlet causes the pump to run for 40 seconds without building system pressure.

2. Connect a piece of clear tubing to the maintenance bleeder. Place the other end of the tubing in a container.

3. Relieve system pressure by loosening the maintenance bleeder. Close the bleeder when fluid stops flowing in the tubing.
4. Connect a piece of $\frac{3}{8}$ inch O.D. hose to the pressure side of a hand-held vacuum pump.
5. Remove the filler cap from the modulator reservoir. Leave the plastic insert in the reservoir opening.
