## Exhaust System Buzz at 1,800 rpm (Supersedes 94-041, dated November 28, 1994)

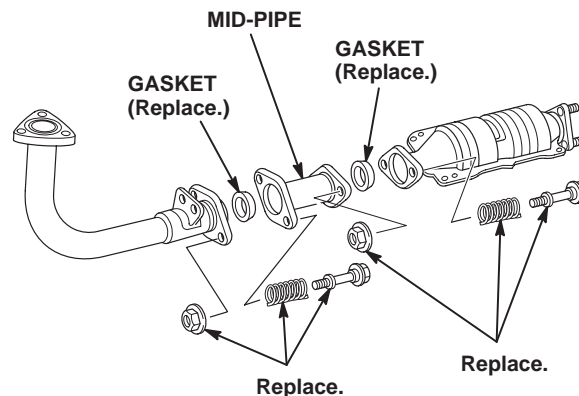
A buzzing noise is heard at 1,800 rpm when accelerating at part throttle. This noise may be heard in cars equipped with either a manual transmission or an automatic transmission (see GENERAL INFORMATION).

Exhaust system resonance.

Replace the gaskets (see PARTS INFORMATION) at both ends of the mid-pipe. Use new mounting hardware.

1. Remove the four bolts mounting the mid-pipe to the catalytic converter and exhaust pipe A.

NOTE: Some models have the heated oxygen sensor mounted in the mid-pipe. Do not damage it while doing this repair.
