Applies To: **2003 Accord** – From VIN 1HGCM5...3A000001 thru 1HGCM5...3A070867  
 – From VIN 1HGCM7...3A000001 thru 1HGCM7...3A020515  
 – From VIN 1HGCM8...3A000001 thru 1HGCM8...3A023939  
 – From VIN 1HGCM6...3A000001 thru 1HGCM6...3A057470

**July 29, 2003**

## Roof Molding Channel Leaks Water

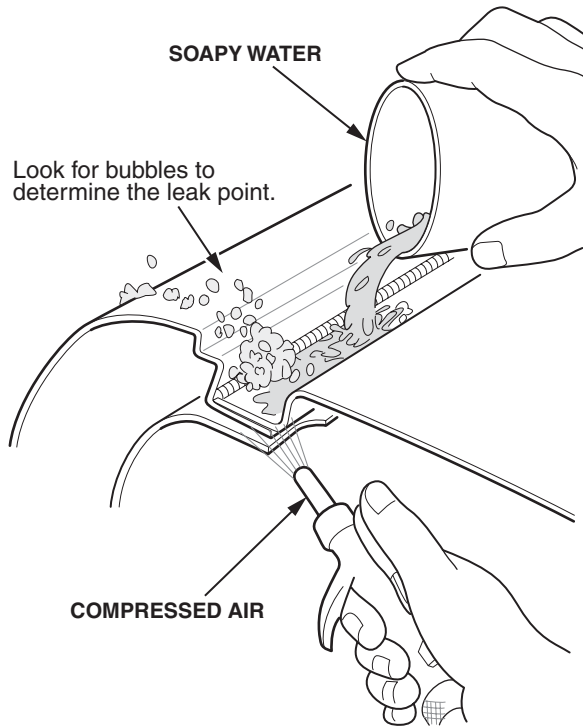
A water leak from the roof stains the headliner.

Insufficient application of sealant.

5. Create a soapy mixture that consists of two tablespoons of liquid detergent and five ounces of water.
6. Pour the soapy mixture into the roof molding channel. Blow compressed air from the interior of the vehicle at the channel to locate and pinpoint the exact location of the leak(s). Be sure to test the full length of the molding channel.

7. Clean and dry the roof molding channel.
8. Apply a liberal amount of 3M ULTRAPRO Autobody Sealant to the area(s) that leaked.
9. Install the new headliner.
10. Reinstall the roof channel molding.
