MIL IS ON WITH BLOWN FUSE 15**TECHNICAL SERVICE BULLETIN**

Reference Number(s): 99-029, Date of Issue: April 20, 1999

HONDA: 1996-1999 Civic

CATEGORY: Engine: Electrical

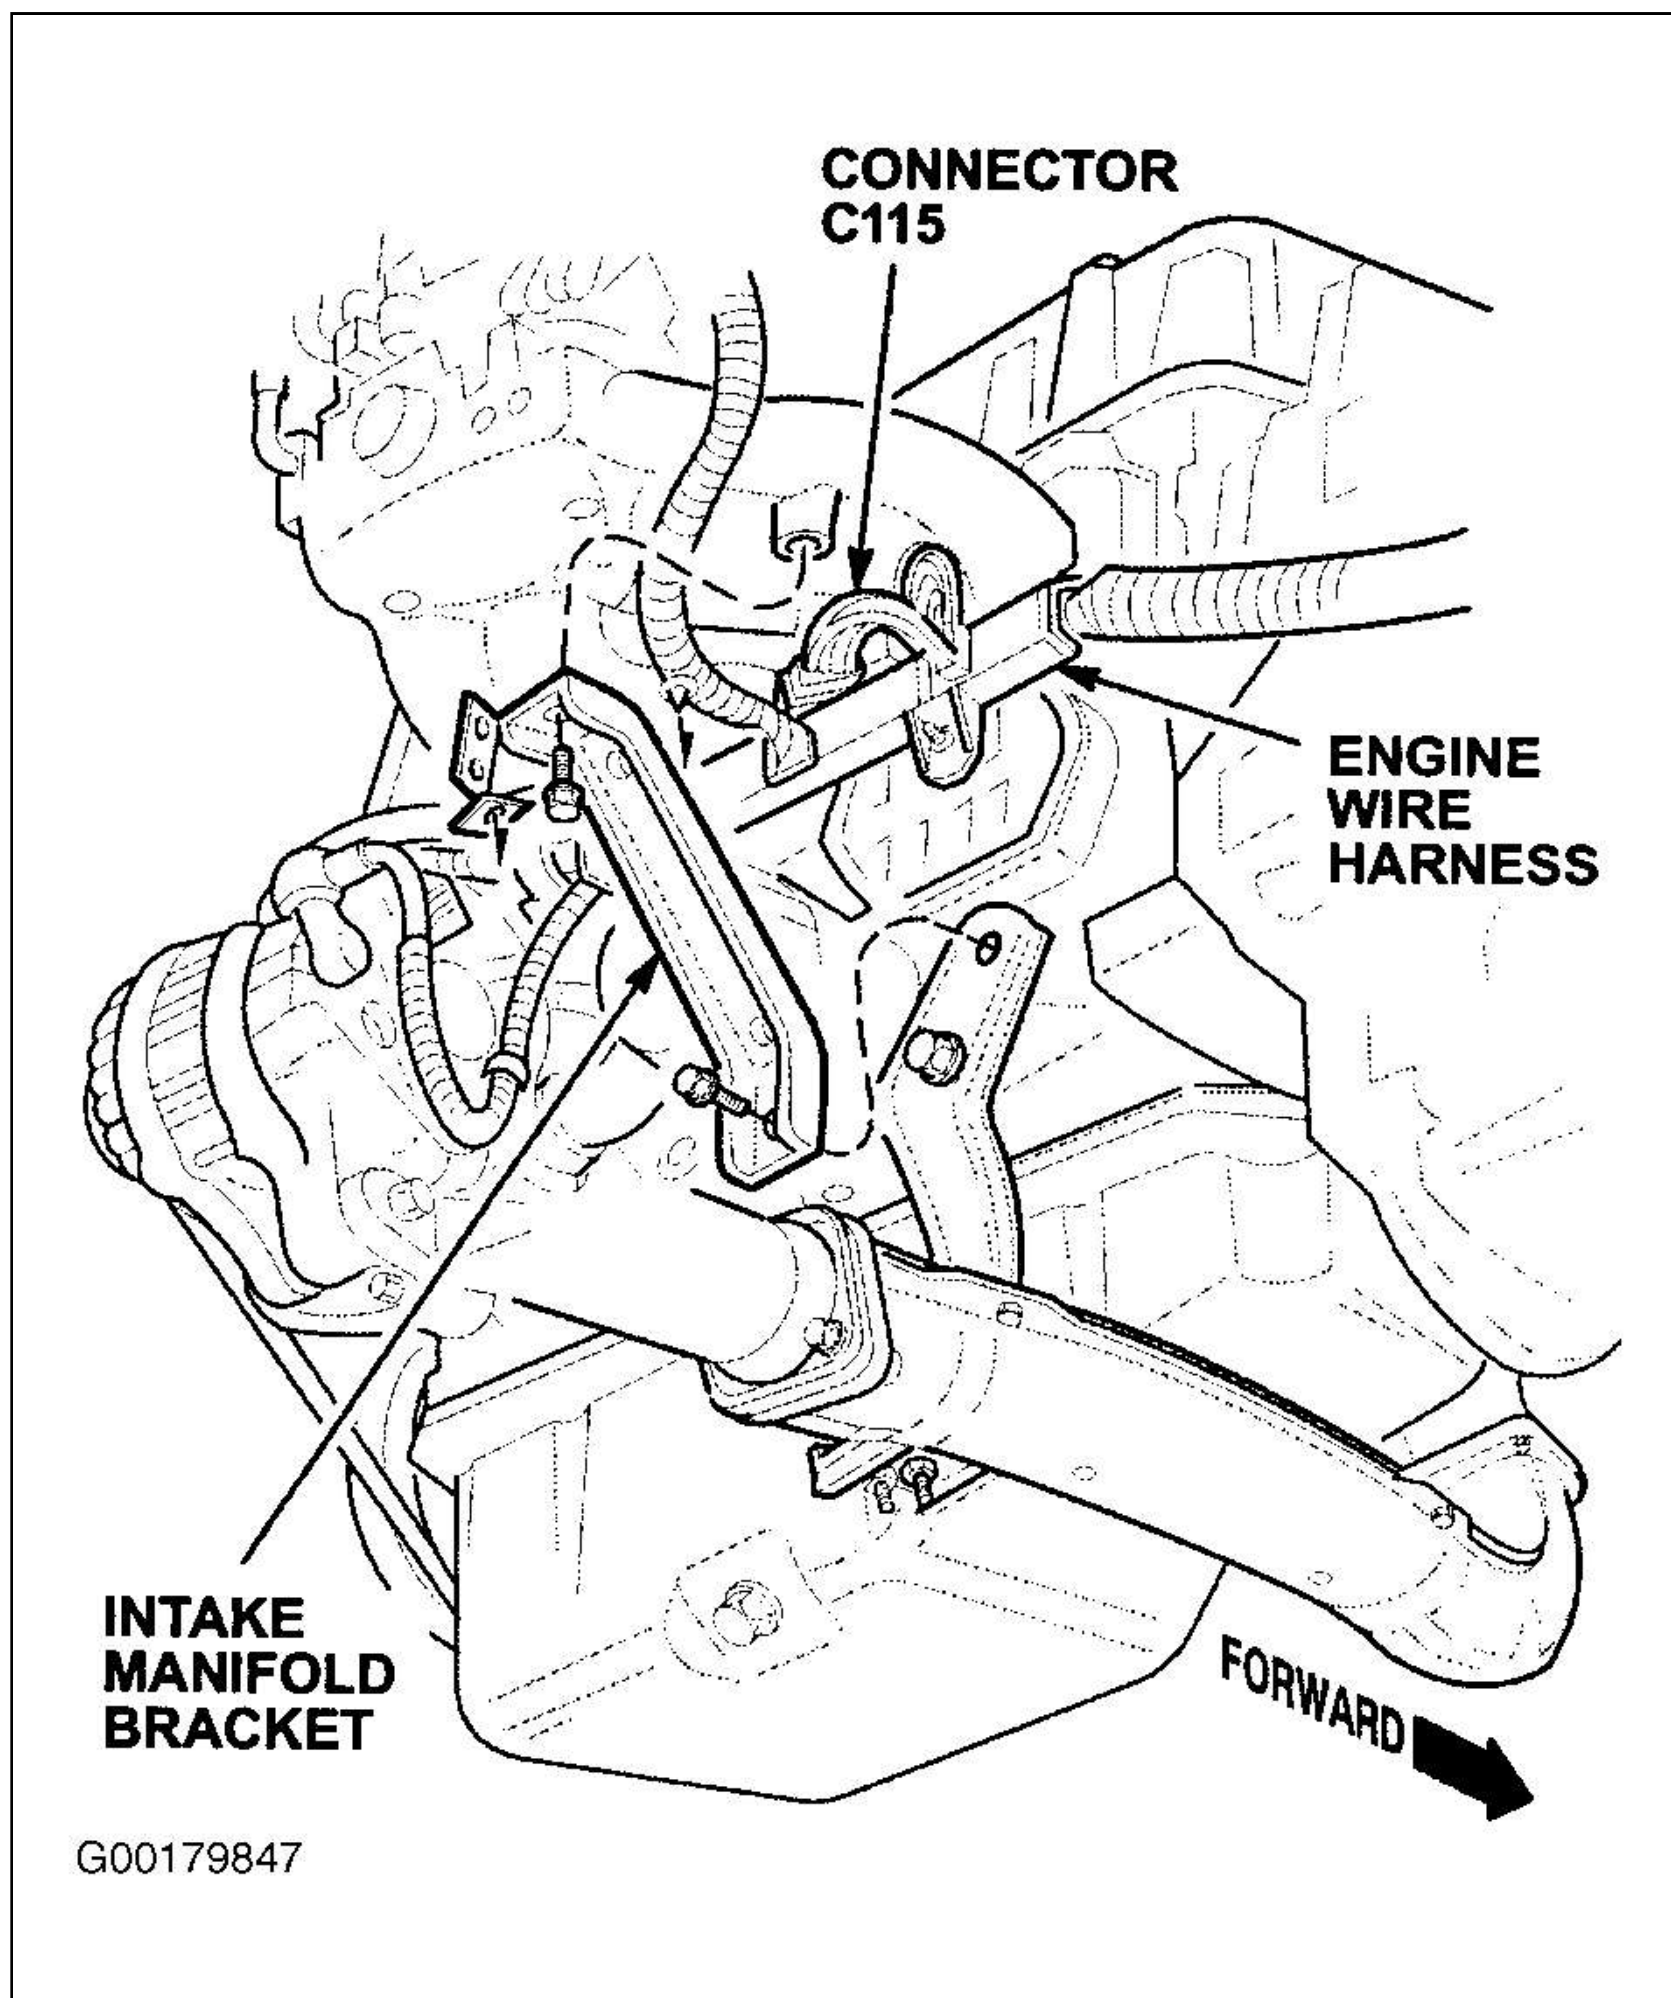
Fig 1: Intake Manifold Bracket

The engine wire harness is rubbing on the intake manifold bracket.

4. Remove the intake manifold bracket. See Fig 1 .

5. Disconnect the engine wire harness from the intake manifold bracket.
