EGR Valve Lift Sensor

1.1 General Overview

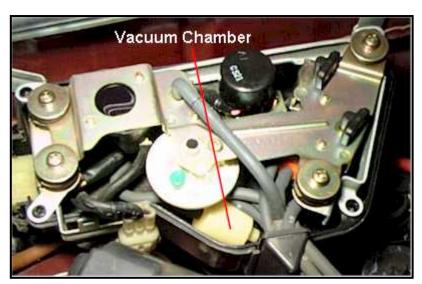
The vacuum chamber is located inside the under-hood emissions box. Image 1-2 shows the location of the vacuum chamber with the lid of the emis-

If the vacuum chamber has been diagnosed as bad, simply replace the EGR lift

sensor vacuum chamber. The part is relatively inexpensive and they seem to be difficult to clean.

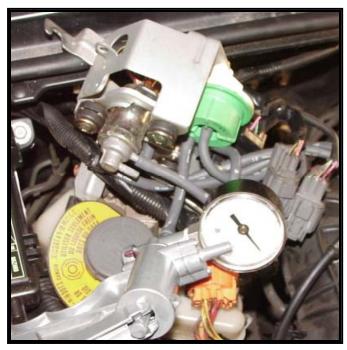
Image 1-3 Checking CVC Vacuum Strength

- Disconnect the vacuum hose at the EGR control solenoid valve that comes from the CVC and attach a vacuum gauge as shown in Image 1-3.
 - Check for the availability of 8" of vacuum with the engine running.
- If the vacuum is not present, check for the availability of manifold vacuum on the other hose on the CVC valve. If manifold vacuum is not present clean the hose and/or its port in

- Replace the CVC Valve if necessary to get 8" of vacuum available to the EGR control solenoid valve.
- Reattach the hose from the CVC to the EGR control solenoid valve and remove hose #16 from the valve. Attach a vacuum gauge to the EGR control solenoid valve as shown in Image 1-4.
- With the engine running, activate the EGR control solenoid valve by grounding the solenoid's pink wire (shown at "A").

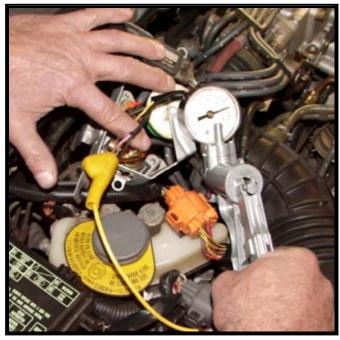
Image 1-5 Checking For a Leaking Vent

- You should now have the same vacuum level you had available from the CVC within 1 second.
- If the vacuum signal is weaker, check the EGR control solenoid valve vent by removing the vent filter so the vent port is visible (shown at "B") and block the vent with your finger as shown in Image 1-5.
- If the vacuum strength increases replace the EGR control solenoid valve.
- Note to also replace the EGR control solenoid valve if the valve fails to supply the same vacuum at the Hose #16 port as it is being supplied by the VCV within 1 second of activation, under any conditions.

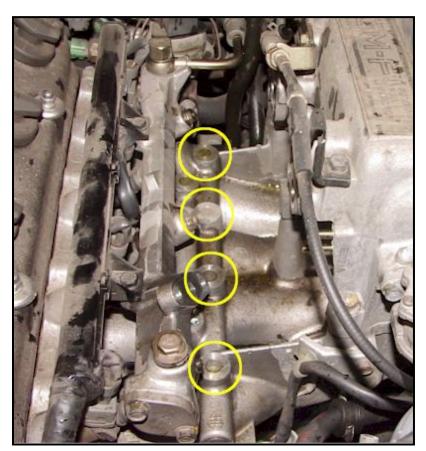
Image 1-6 Ports Visible with IAC and Fast Idle Valves Removed

Remove the IAC Valve and Fast Idle Valve as needed to get a clear access to the 4 EGR port plugs. The plugs are shown in Image 1-6.

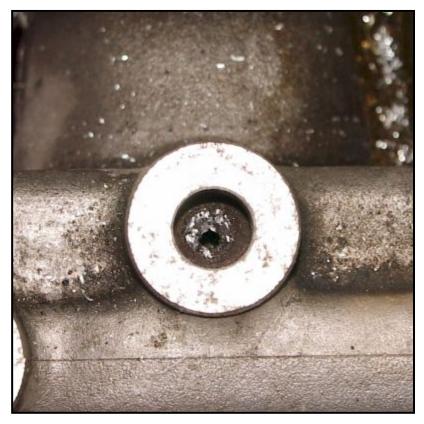
After the plugs are removed, the ports will typically look like the port shown in Image 1-9.

Use a pick to break up the hard carbon and then use solvent and compressed air as needed to get the port clean.

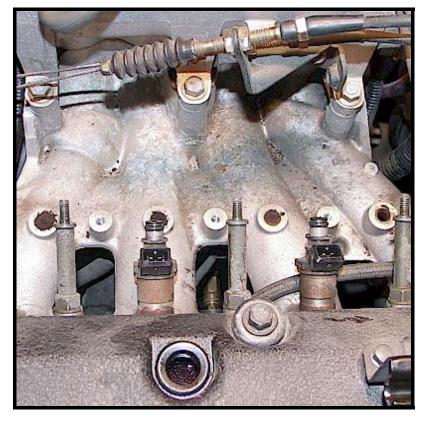
Image 1-12 Intake With 3 of 4 Clogged EGR Ports

After removing the EGR port top cover and base gasket the 4 EGR ports are easily accessible. In this photo you can see that 3 of the 4 EGR ports are completely clogged with carbon.

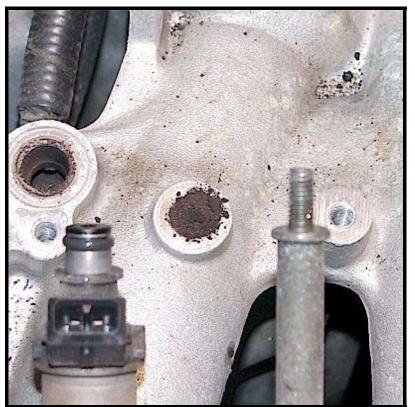
Image 1-13 Close Up of Clogged EGR Port

Here is a closeup shot of a clogged EGR port.

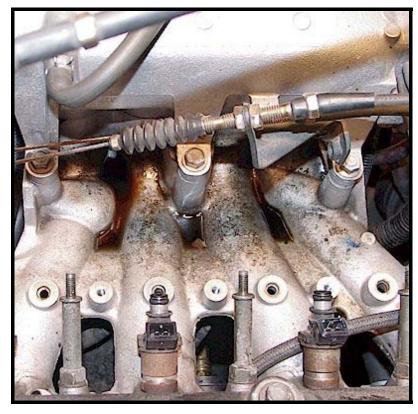
Image 1-14 All Ports Cleaned and Ready For Reassembly

Here is a picture of all 4 ports cleaned up and ready for reassembly. Cleaning is best done with a pick and then a bottle type wire brush.

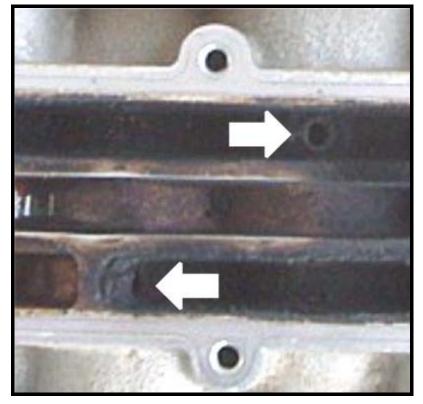
Image 1-17 Details On EGR Ports

In Image 1-17 you can see the top EGR port is clear and the bottom EGR port is almost totally blocked.

The 95-97 Accord V-6s have a removable EGR port service plate. After removing the plastic top engine cover, simply remove the EGR port service plate that is bolted to the top of the intake runners. Then clean the ports using a bottle brush as shown in the following images.
