1996 Honda Accord
F22B2 Engine

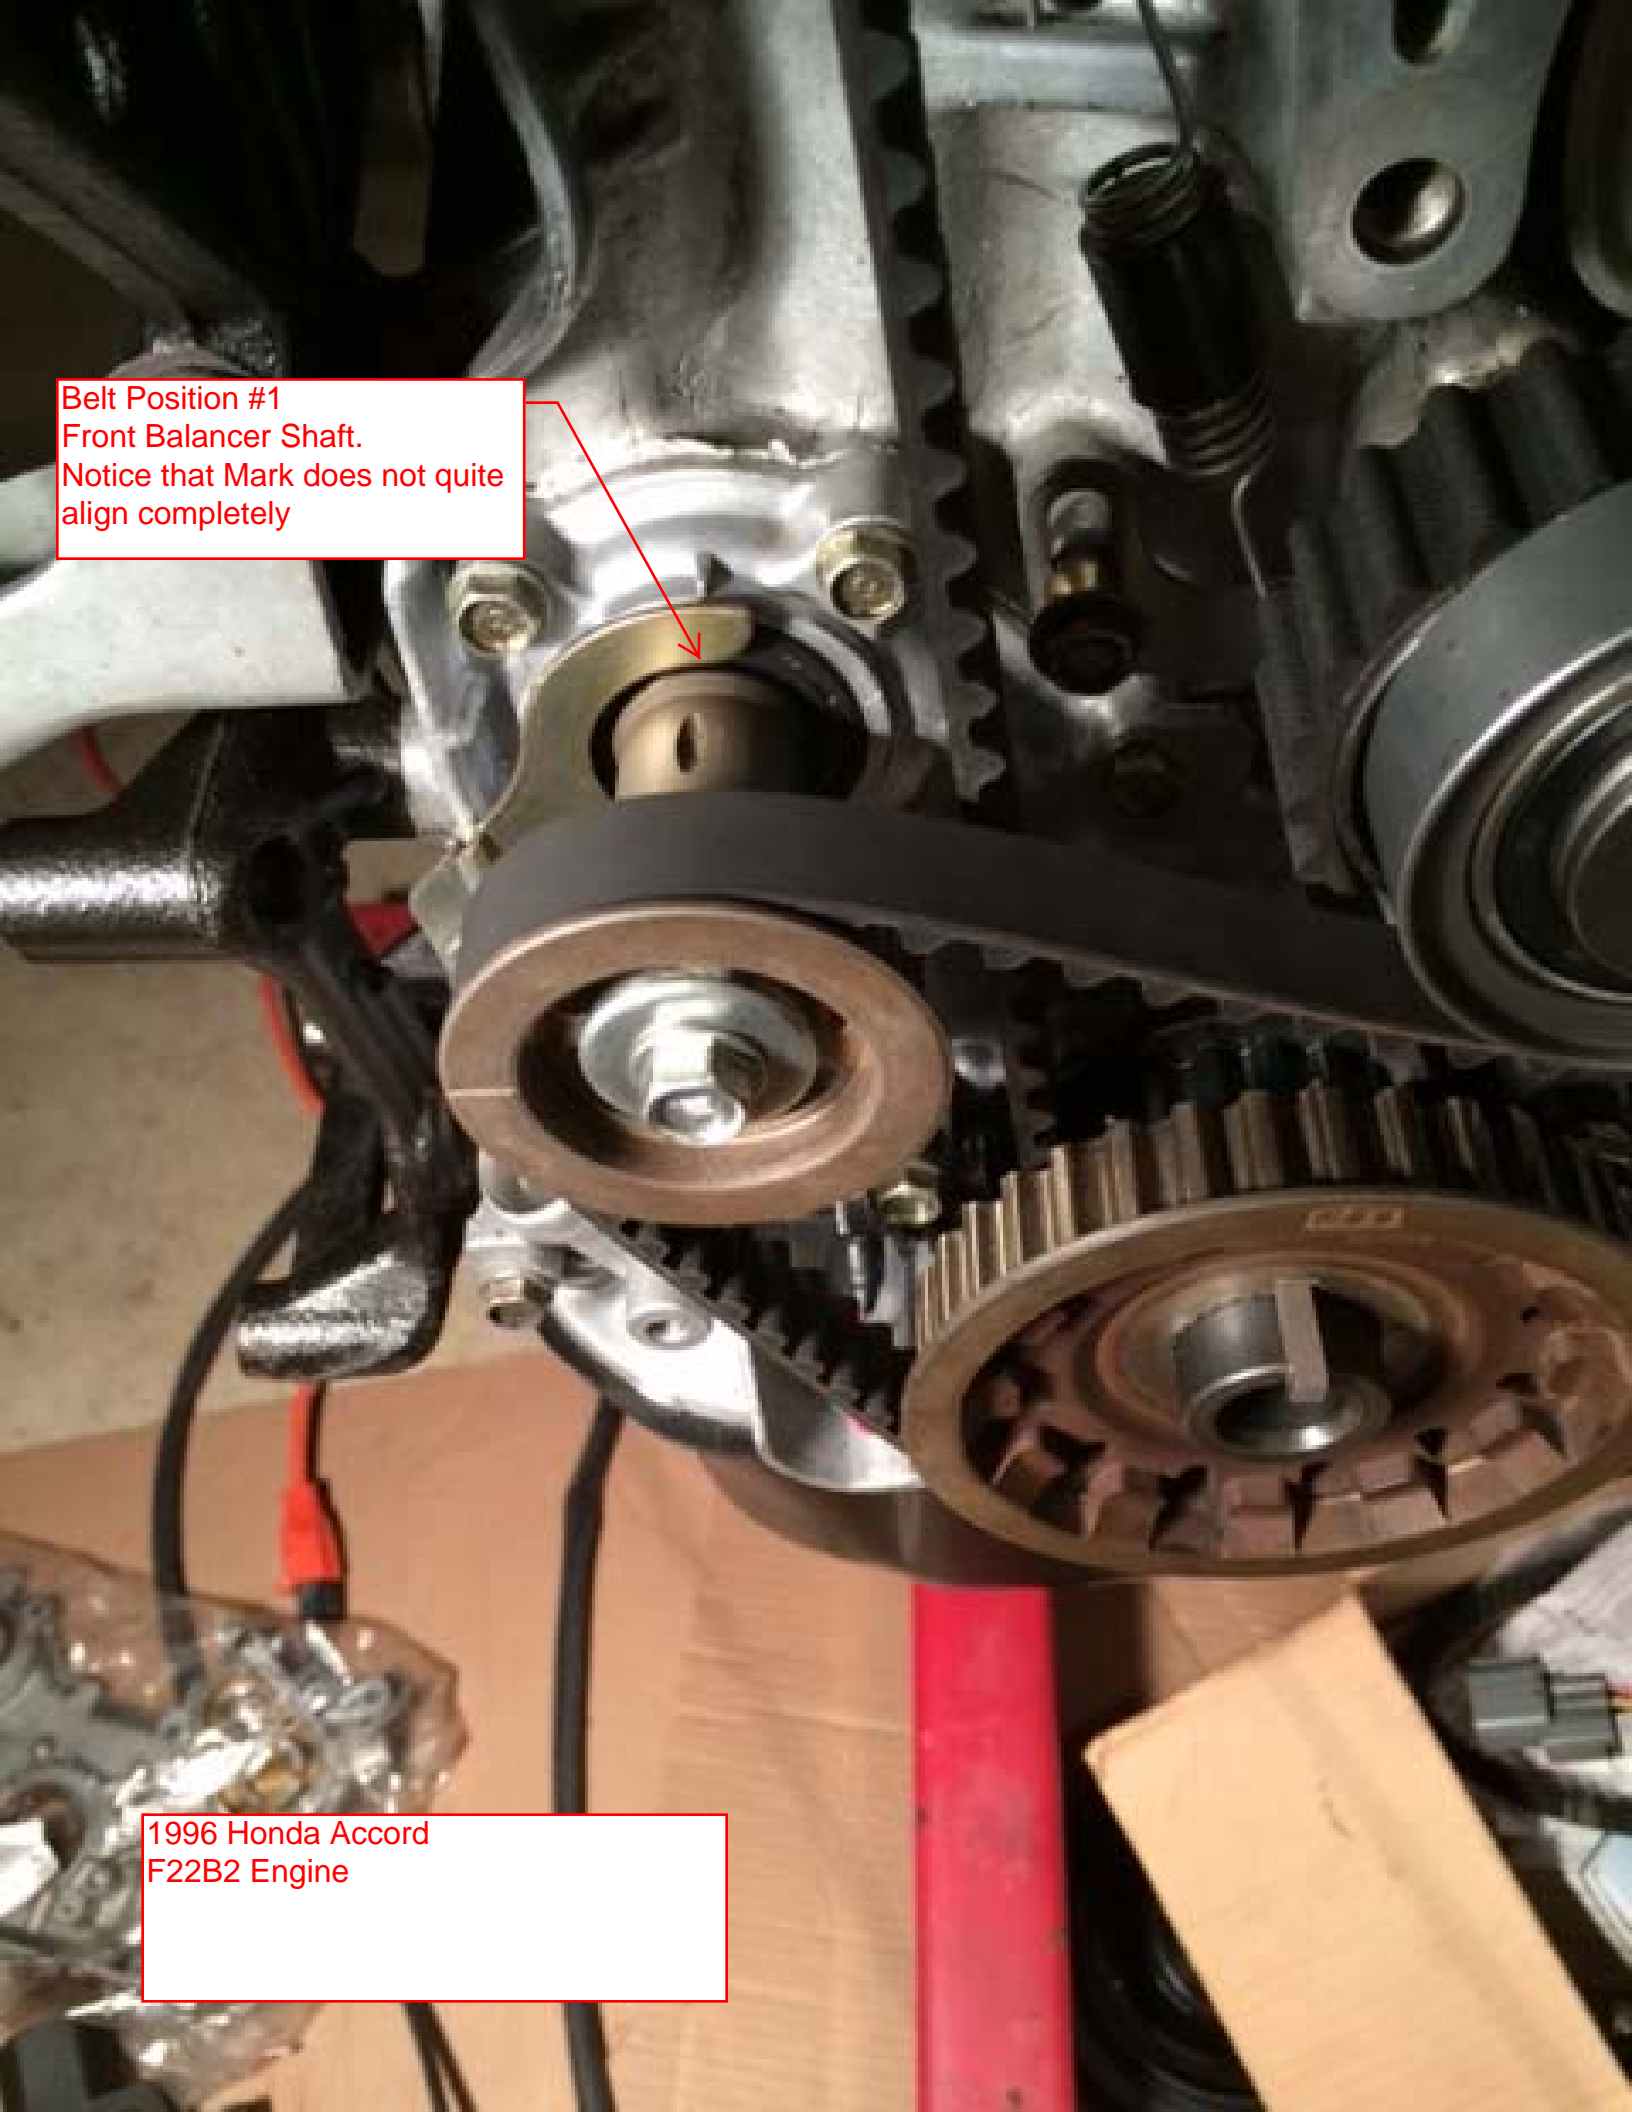
Belt Position #1
Front Balancer Shaft.
Notice that Mark does not quite
align completely

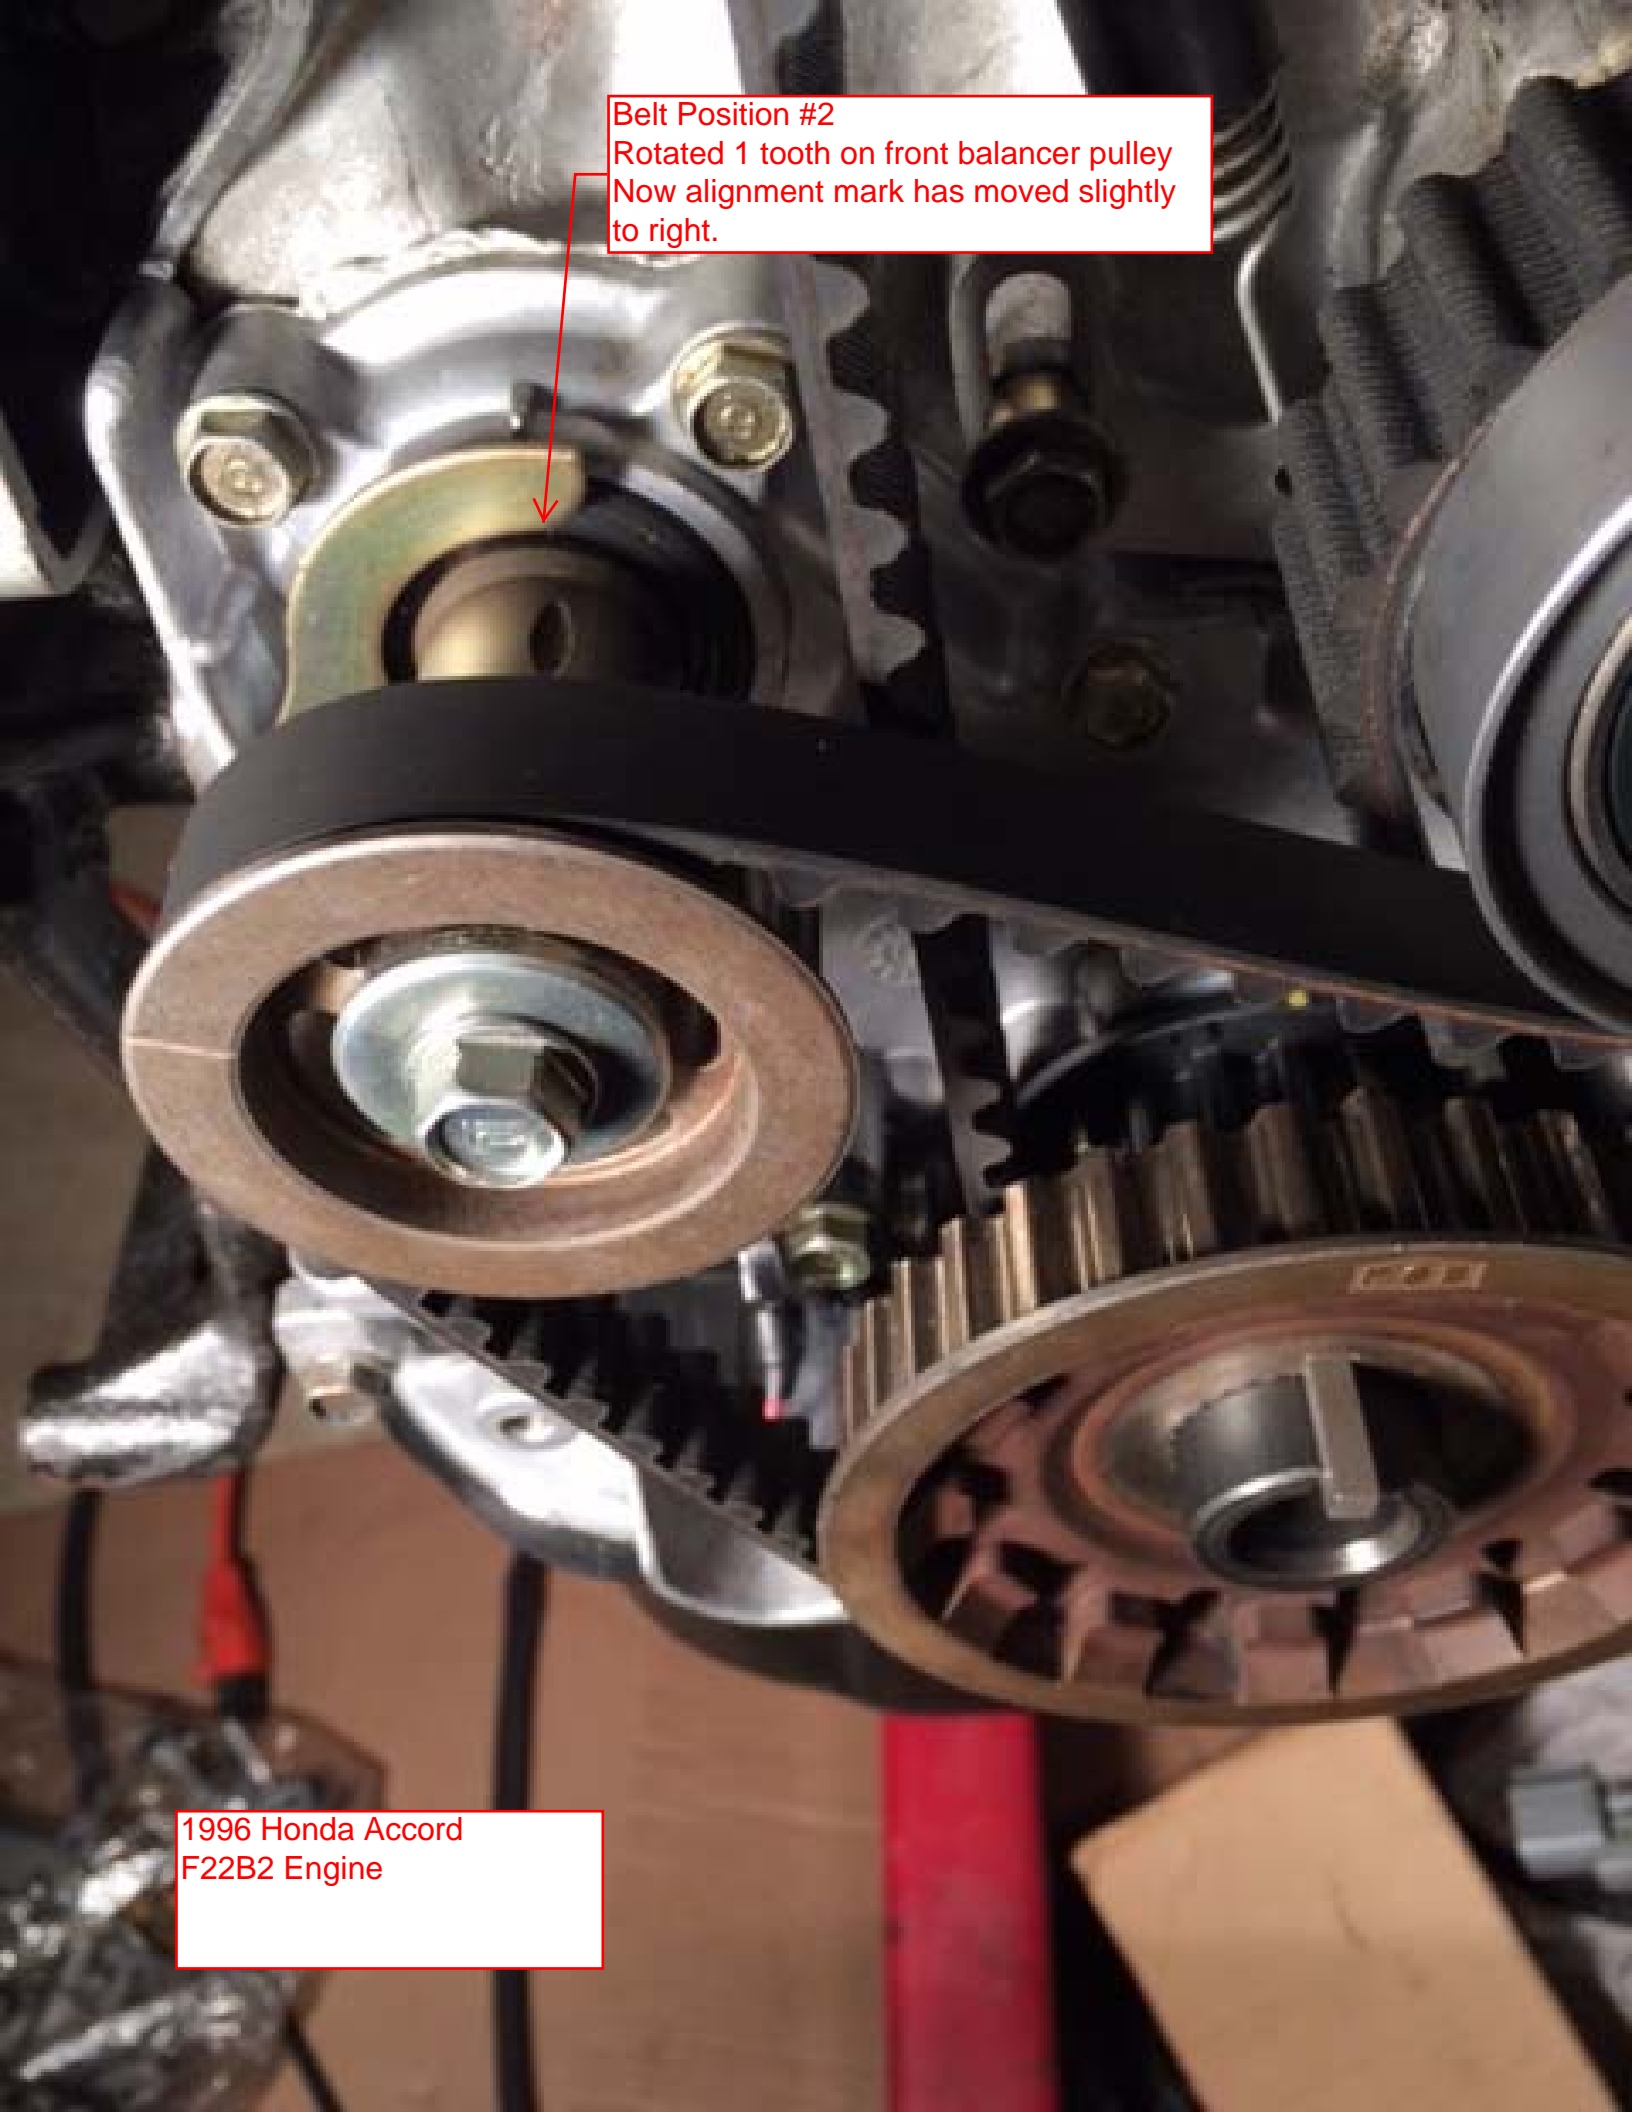
Belt Position #2
Rotated 1 tooth on front balancer pulley
Now alignment mark has moved slightly
to right.

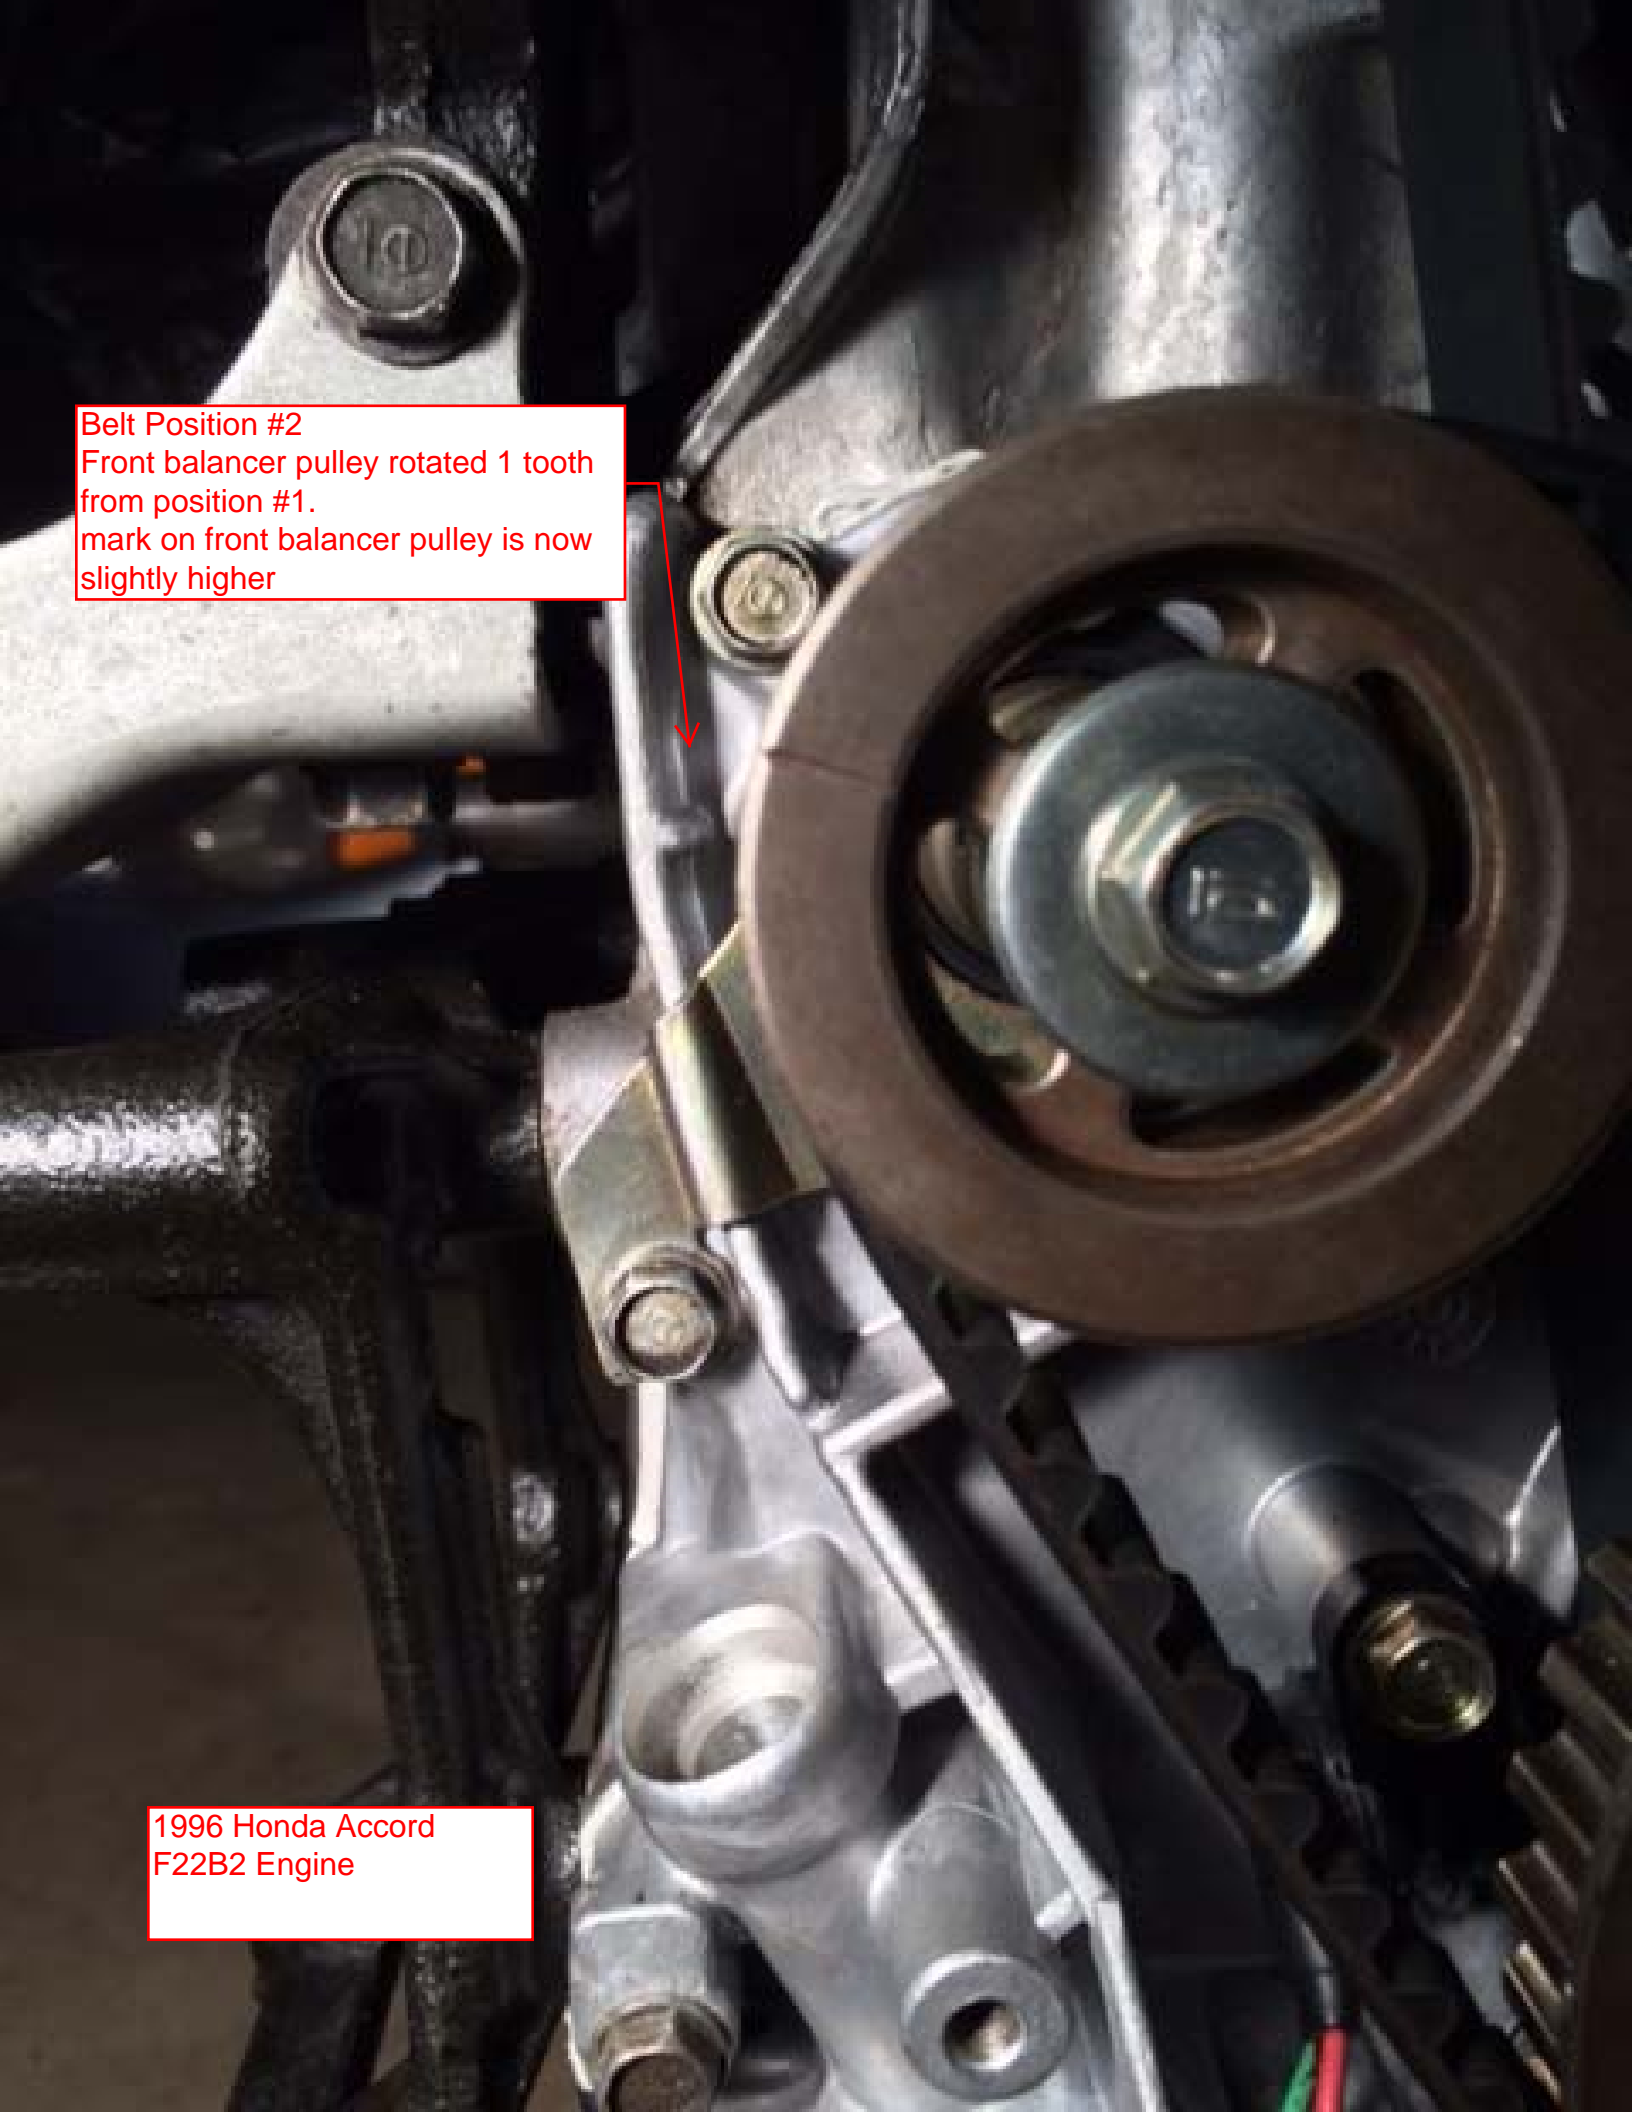
Belt Position #2
Front balancer pulley rotated 1 tooth
from position #1.
mark on front balancer pulley is now
slightly higher

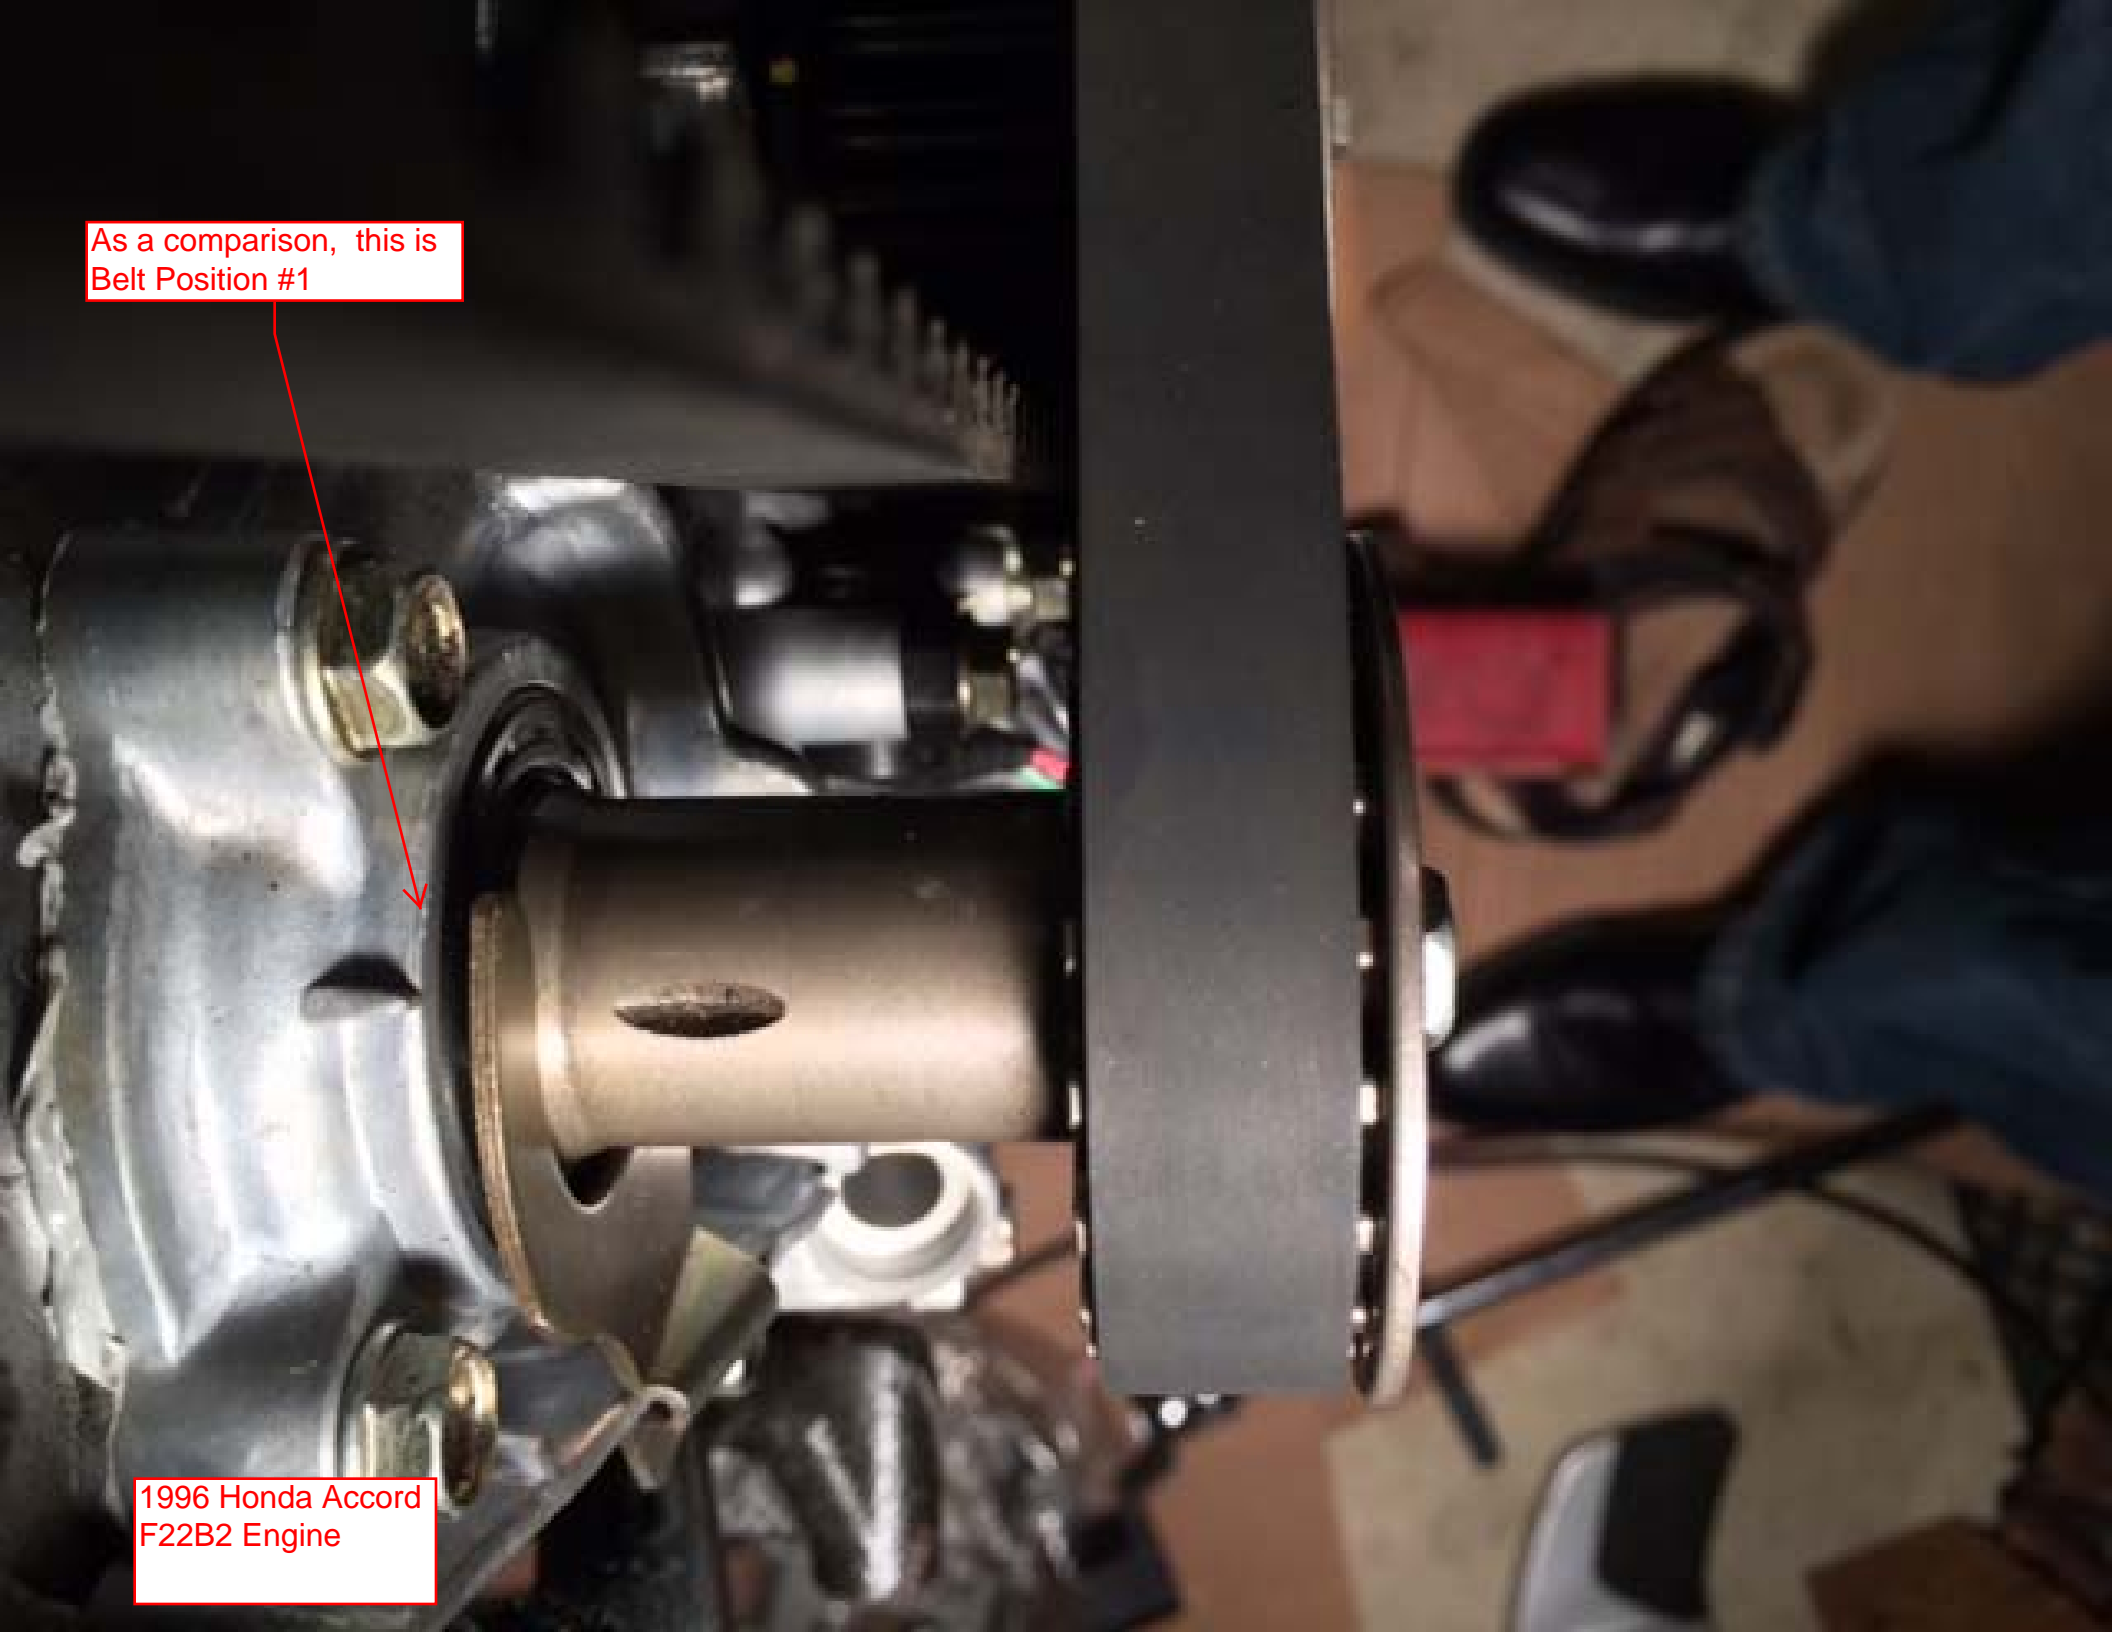
As a comparison, this is Belt Position #1
