EGR Valve Lift Sensor

1.1 General Overview

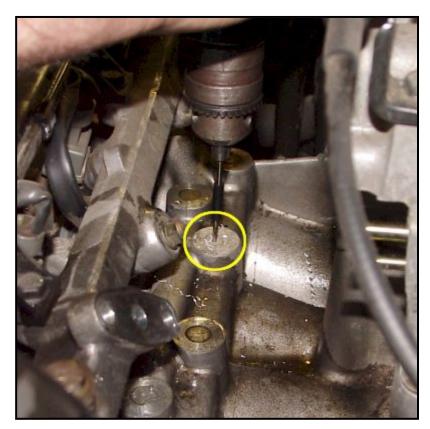
Remove the IAC Valve and Fast Idle Valve as needed to get a clear access to the 4 EGR port plugs. The plugs are shown in Image 1-6.

Center punch and drill a small hole in the middle of the plugs, as shown in Image 1-7.

The hole doesn't have to go all the way through the plug, just about a 1/4" deep (remember to put grease on the bit to catch the chips just in case you drill through).

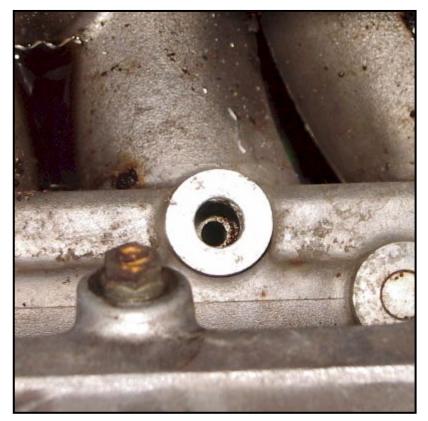
After the plugs are removed, the ports will typically look like the port shown in Image 1-9.

Use a pick to break up the hard carbon and then use solvent and compressed air as needed to get the port clean.

After the ports have been cleaned (as shown in Image 1-10) replace the plugs.

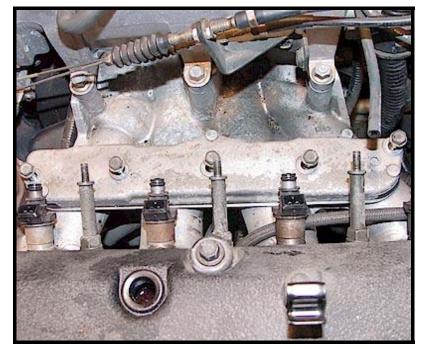
Image 1-11 EGR Port Access Plate

On 94-1997 Accord L4 engines, the EGR ports can be reached by removing a cover. This cover is shown in Image 1-11.

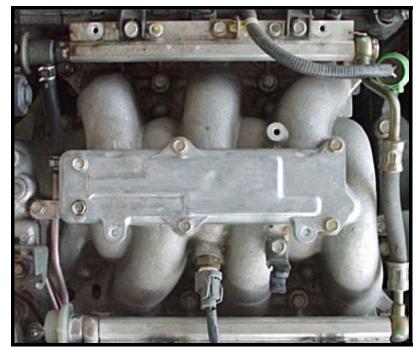
Image 1-15 EGR Port Service Plate

The 95-97 Accord V-6s have a removable EGR port service plate. After removing the plastic top engine cover, simply remove the EGR port service plate that is bolted to the top of the intake runners. Then clean the ports using a bottle brush as shown in the following images.

Remove the plastic covers from the top of the intake manifold. Remove the 6 screws that hold the EGR port inspection cover onto the top of the intake manifold as shown in Image 1-15.

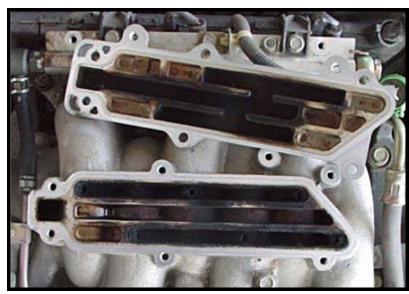
Image 1-17 Details On EGR Ports

Once the service plate is removed, you can see the six ports that feed the exhaust flow into the individual intake runners.

In Image 1-17 you can see the top EGR port is clear and the bottom EGR port is almost totally blocked.
