Applies To: 1999 – 02 Odyssey – ALL

2003 Odyssey – From VIN 2HKRL18..3H500001 thru 2HKRL18..3H504511
and from VIN 5FNRL18..3B000001 thru 5FNRL18..3B067057
2003 Pilot – From VIN 2HKYF18..3H500001 thru 2HKYF18..3H567864

Warranty Extension: EGR Valve Contamination or EGR Port Clogging May Cause DTC P0401, DTC P1491, or Engine Hesitation/Surge (Replaces 00-009, Odyssey Warranty Extension: EGR Port Clogging, dated March 4, 2003)

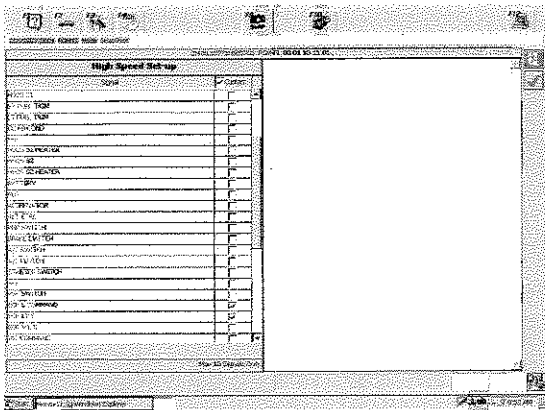
- From the **High Speed** menu screen, select these parameters: **Engine Speed**, **VSS**, **ECT Sensor**, **Map Sensor**, **TP Sensor**, **EGR-L-Command**, and **EGR LIFT**. Then select the green **Check** button.

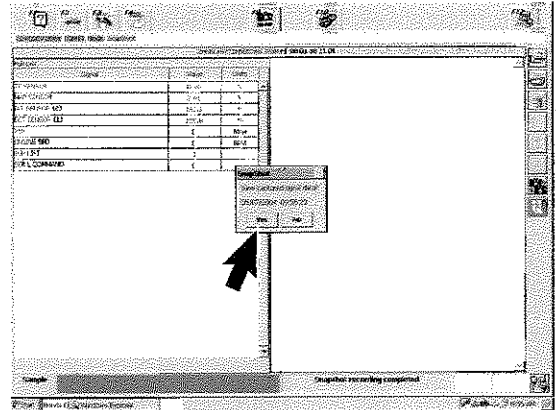
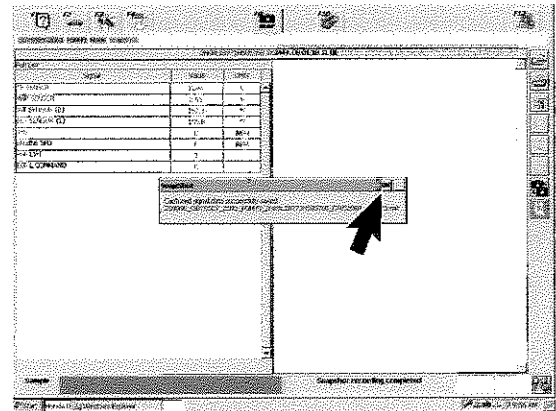
- When the drive is complete, the **Snapshot** dialog box is displayed. Select **Yes**, then select **OK**. This stores the snapshot.
