Fig. 6: Testing Seat Heater Switch Continuity
 Courtesy of AMERICAN HONDA MOTOR CO., INC.
 1997 Acura 3.0CL

POWER SEATS

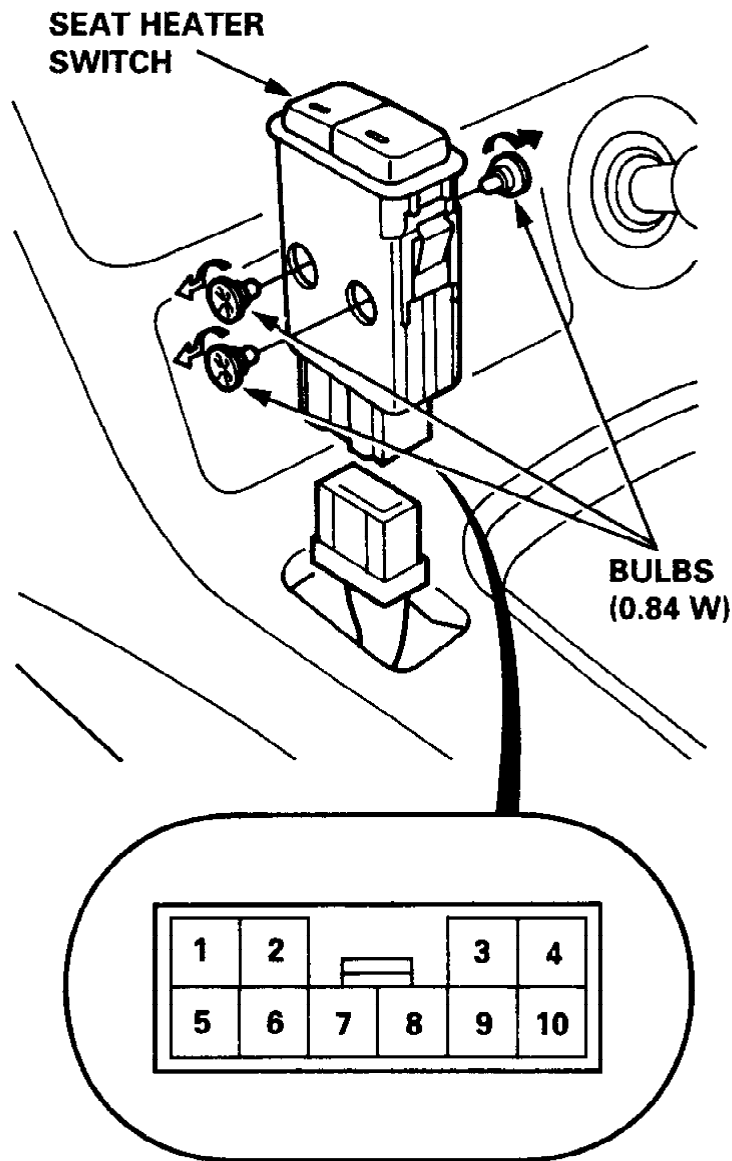
Terminal		2		3	5	6		7		9	10
Position											
ON	DRIVER'S	○	⊗	○	○	⊗	○	⊗	○	○	○
	PASSENGER'S	○	⊗	○	○	⊗	○	⊗	○	○	○
OFF		○	⊗	○	○	⊗	○	⊗	○	○	○

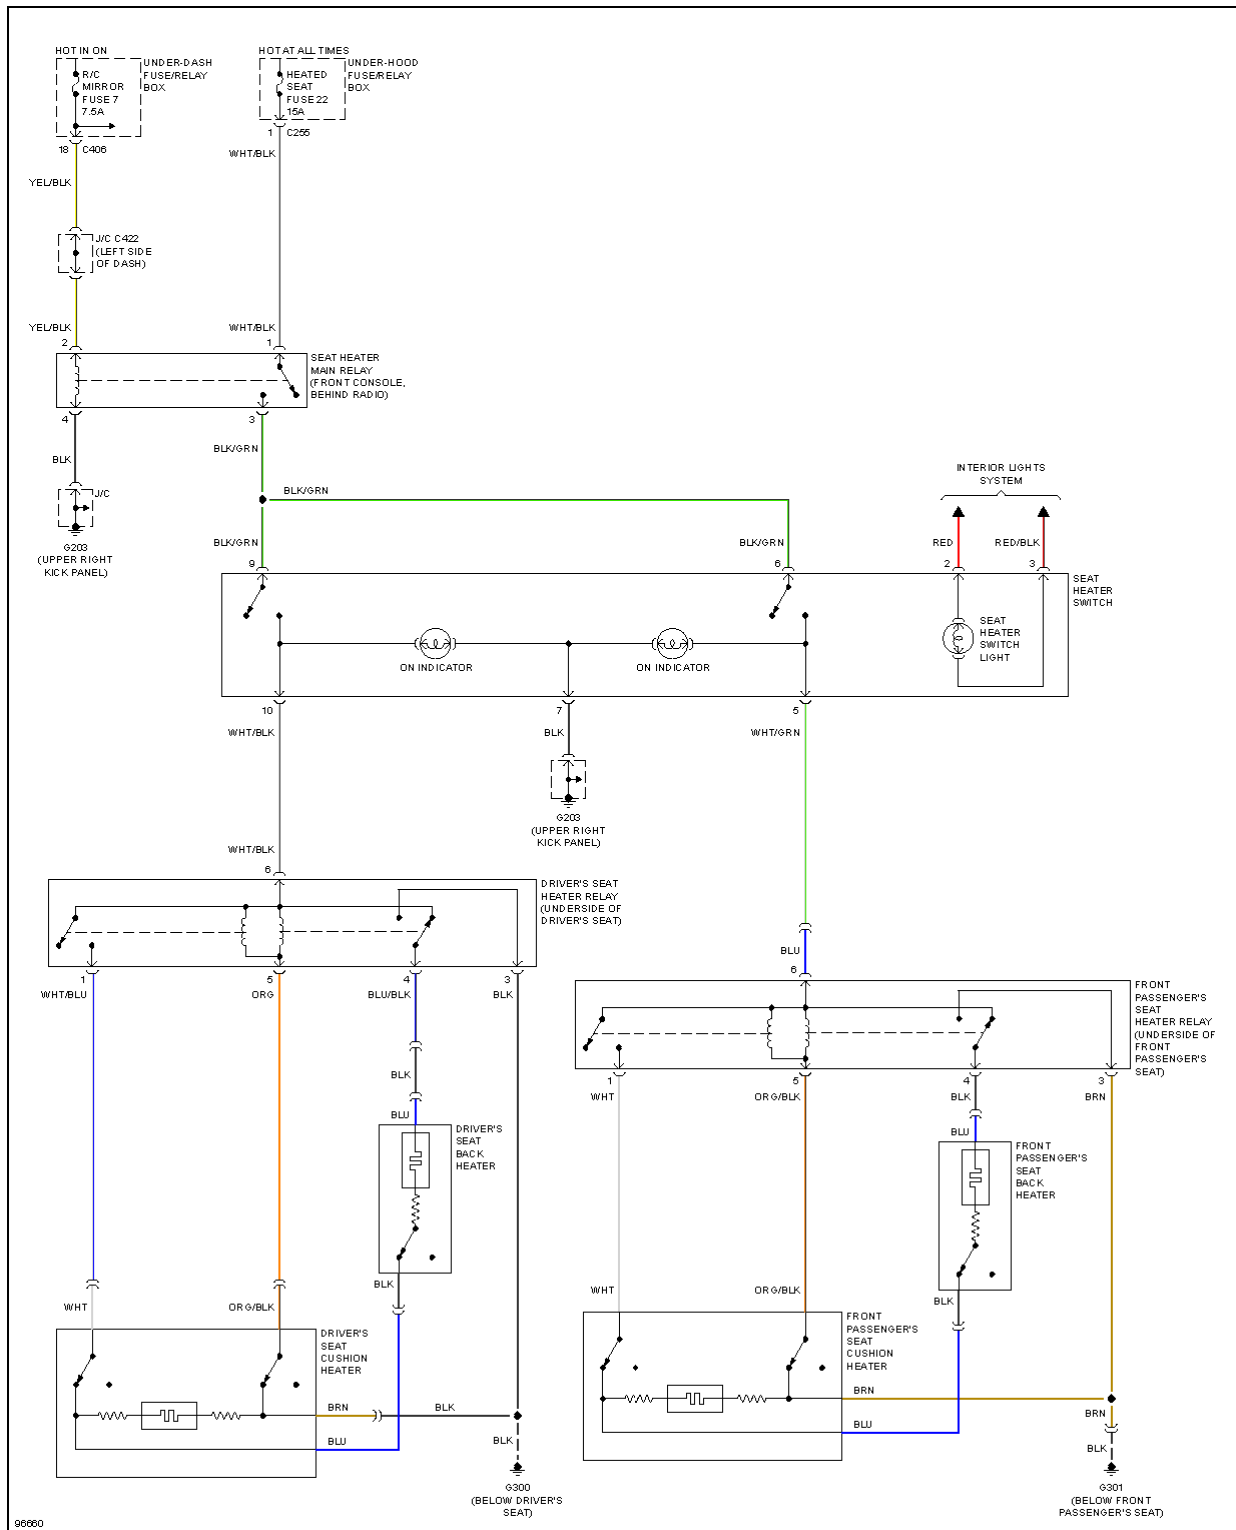
Fig. 10: Heated Seats System Wiring Diagram
