Issue Date: October, 2000  
Application: 90-93 Accords

## Opening a Door With a Stuck Door Latch

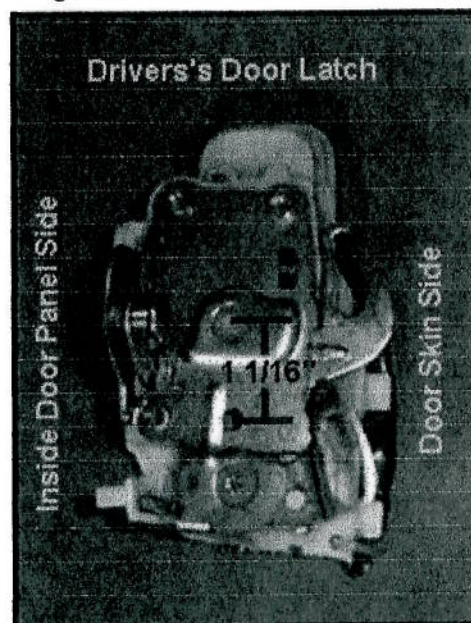
Measure from the center of the "pivot rivet" drop down 1 1/16" and center punch a hole. The hole should be horizontally about 1/8" from the embossed stiffening ridge (to the door skin side). See Image 1 for reference.

Drill this hole with a 1/8" drill bit. Stop when the bit goes through the first layer of metal. Redrill the hole using a 1/4" drill bit. After drilling through the first layer, let the drill bit go further and hit the internal parts of the latch.

Normally the drill bit will hit the right latch part and the latch will release. If it does not, use a

screwdriver through the 1/4" hole to release the latch. Simply turning and moving a flat screwdriver tip inside the 1/4" hole will usually release the latch. If all else fails, drill this hole larger and try again to hit the release.
