**Brake System Indicator On After Brake Fluid Replacement**

Currently Applies To: '03–07 Accords

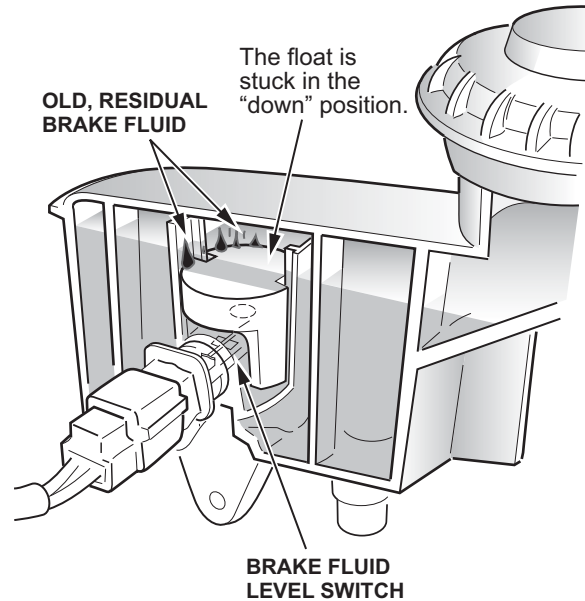
Just replaced the brake fluid, but that brake system indicator in the instrument panel is still on? Old, residual brake fluid in the reservoir can cause the float for the brake fluid level switch to stick in the down position, causing the indicator to stay on.

To fix this problem, follow these steps:

1. Use the handle end of a screwdriver to tap on the top of the reservoir.
  - If the brake system indicator goes out, you're done with this repair.
  - If the brake system indicator stays on, go to step 2.
2. Drain the brake fluid from the reservoir.
3. Remove the mounting screw holding the reservoir to the master cylinder, and remove the reservoir.
4. Carefully remove the rubber seals, and use brake cleaner to remove any old, residual brake fluid from the inside of the reservoir.
5. Use shop air to dry the reservoir, then shake it to make sure that the float moves freely.
6. Use fresh Honda Genuine DOT 3 brake fluid to lubricate the rubber seals, then reinstall the reservoir.
7. Fill the reservoir with fresh brake fluid to the MAX (upper) level. Then check for leaks.
8. Make sure that the brake system indicator in the instrument panel is off.
