P1078 HONDA - Intake Manifold Runner Control System Malfunction High RPM

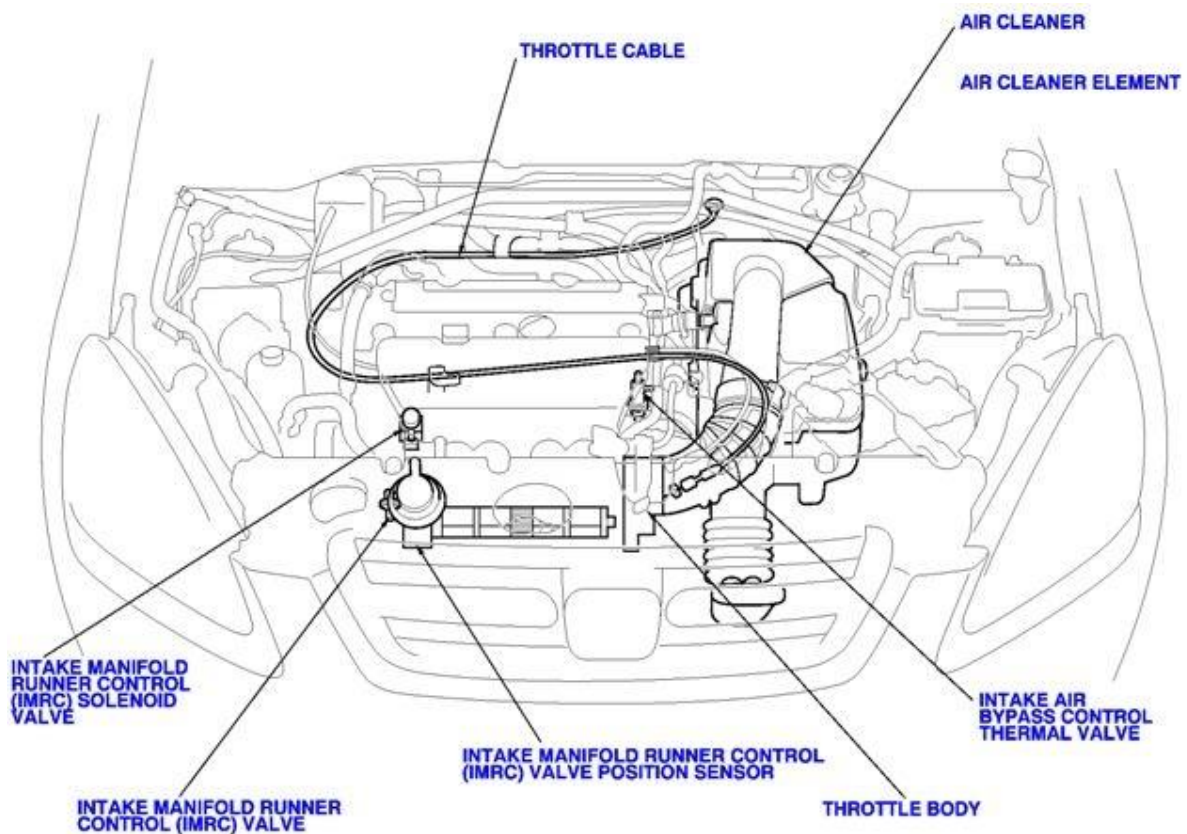
**IMRC
Solenoid
Valve
(2-BLK)**

P1078 HONDA Description Engine power is achieved by closing and opening the Intake Manifold Runner Control (IMRC) valve. When the valve is closed, there is high torque at low engine speed. When the valve is open, there is high torque a high engine speed.

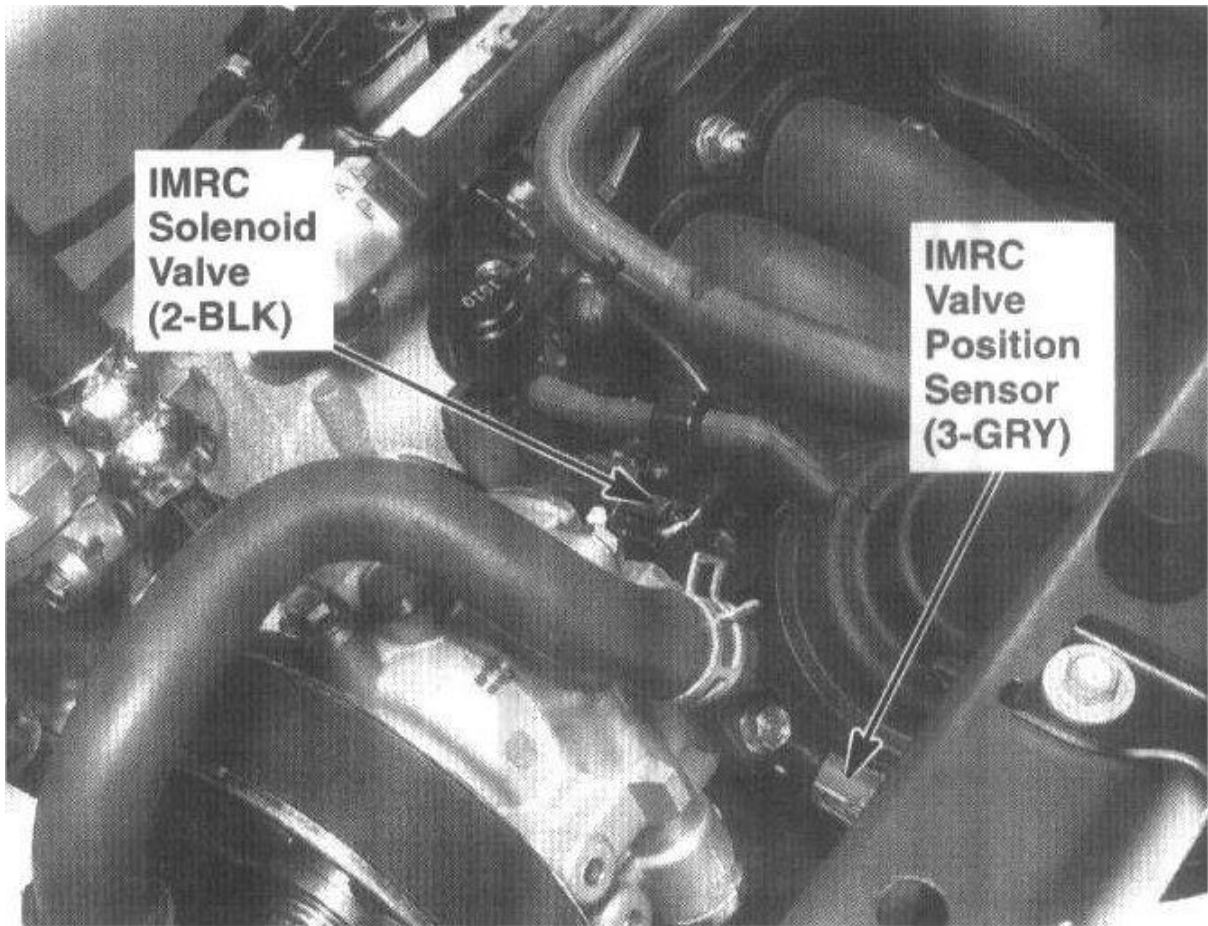
**IMRC
Valve
Position
Sensor
(3-GRY)**
